ON-SITE AMBULANCE CRASH INVESTIGATION

CASE NUMBER - IN11024

VEHICLE - 1996 FORD E350 TYPE III AMBULANCE

CRASH DATE - July 2011

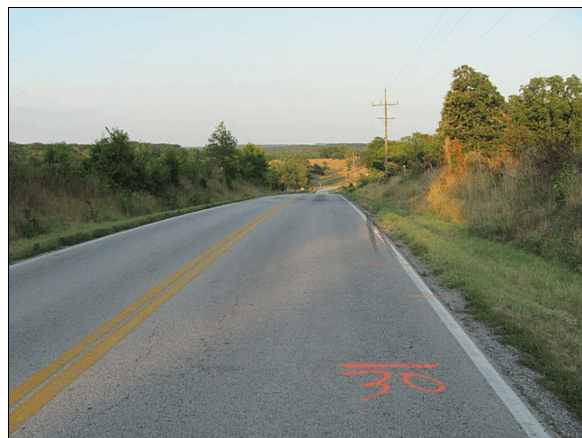
Pre-Crash: The ambulance was traveling east (Figure 2) and had just crested of a hill, which was located 63 m (206.6 ft) west of the impact area. Westbound vehicles were slowing and

Figure 2: Approach of the ambulance eastbound to the area of impact, number shows meters to impact area

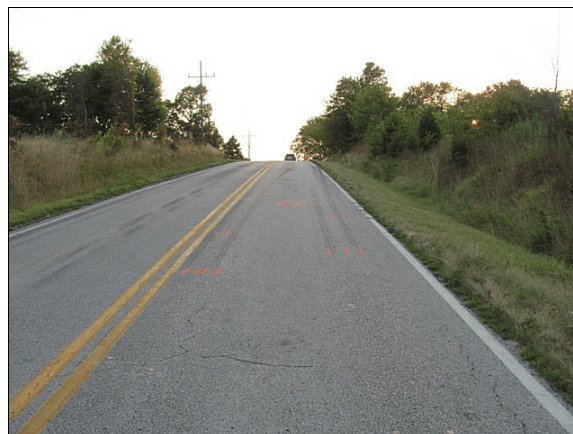
stopping to yield to the ambulance as it approached. The Peterbilt was westbound (**Figure 3**) behind these vehicles and the Peterbilt's driver applied lock-wheel braking in an attempt to avoid the vehicle in front of him. The Peterbilt skidded 30 m (98.4 ft) as it rotated counterclockwise approximately 25 degrees to impact in the eastbound lane. The driver of the ambulance initiated a right steering maneuver and applied lock-wheel braking in an attempt to avoid the crash. The vehicle's right side wheels departed the edge of the roadway as it skidded 17 m (55.8 ft) to impact.

Figure 3: Approach of the Peterbilt westbound to the area of impact
